Autonomous Robot System for Monitoring and Cleaning of Bridges

**Monitoring and Maintenance Robotic System for San Giorgio Bridge
(Genoa, Italy)**

FULLY AUTONOMOUS Robot for inspecting the Genova San Giorgio bridge

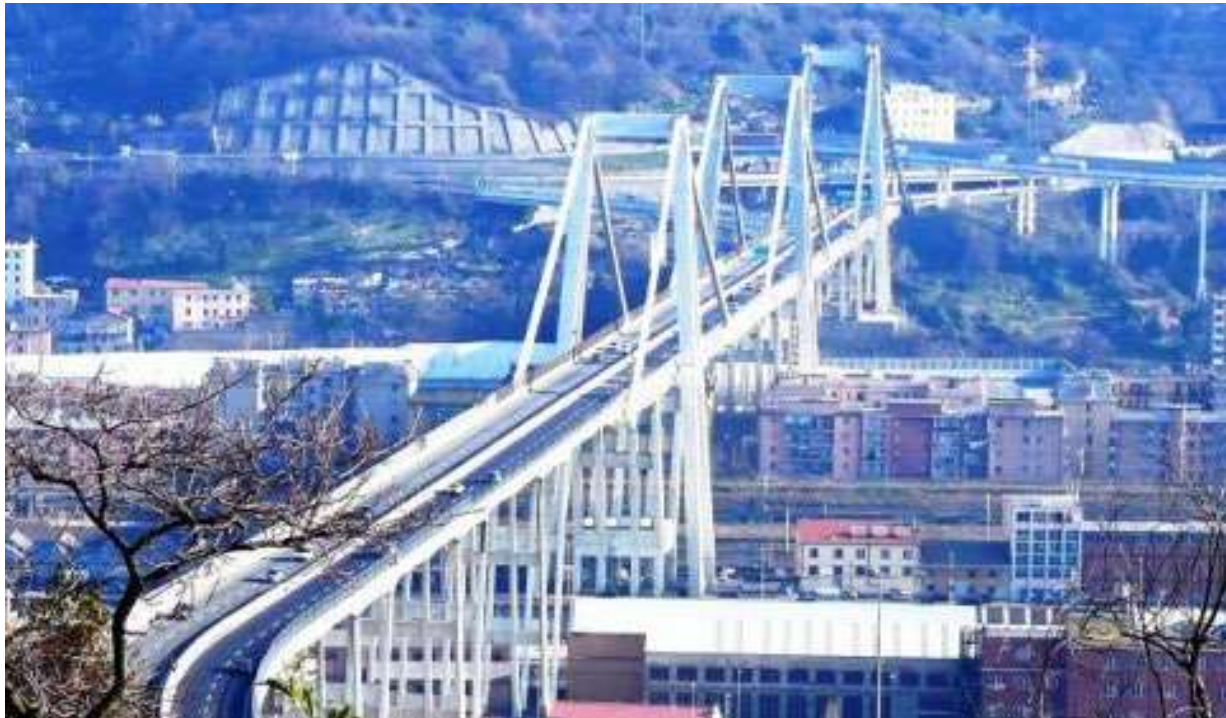
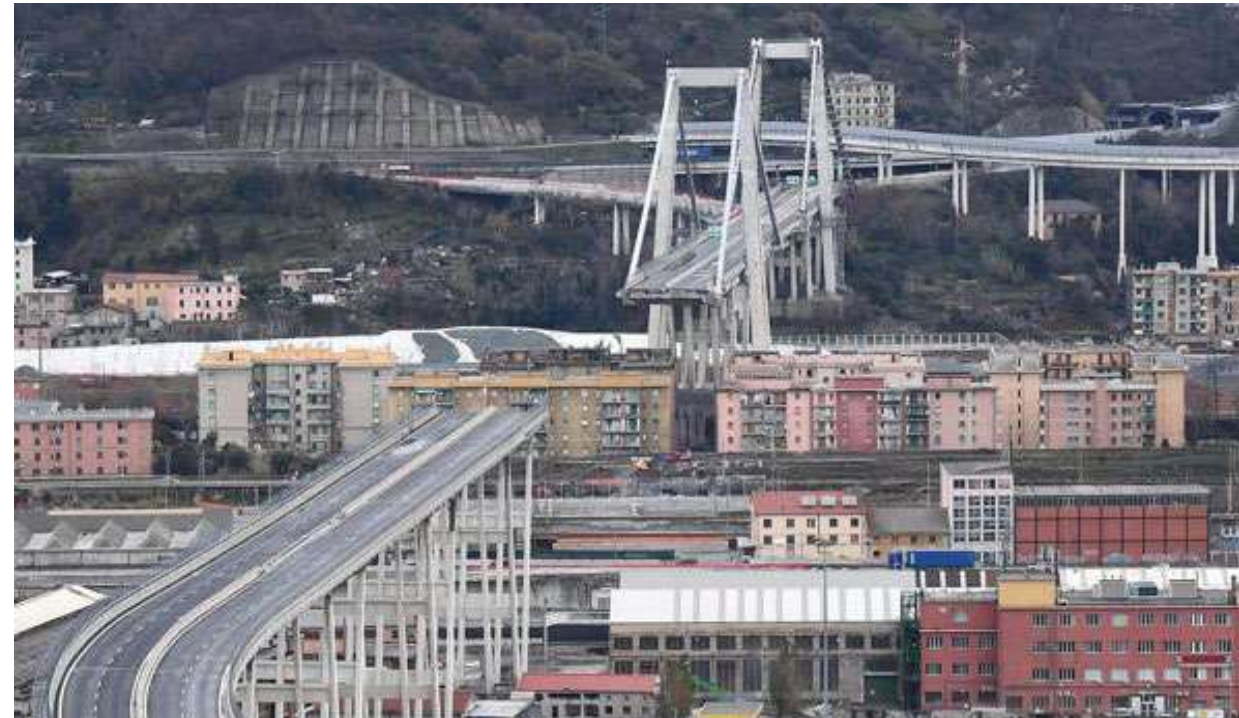
Morandi's Bridge before and after the collapse of the Pillar 9
(14th August 2018 at 11:36am with 43 victims and 16 injuries)

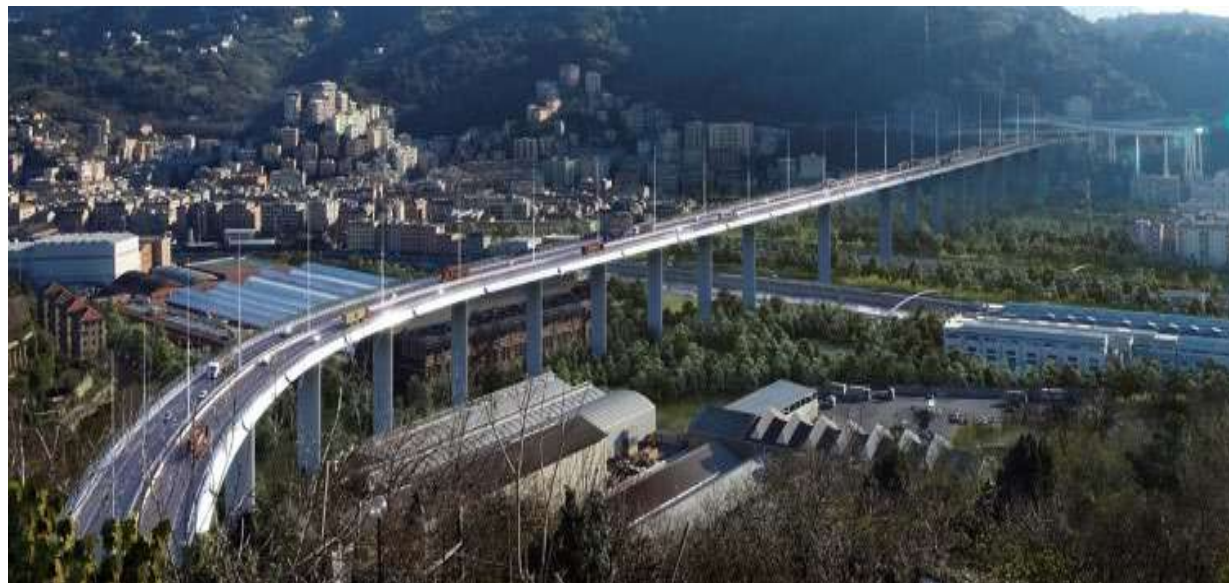
Very Efficiency in Building: <24 months!

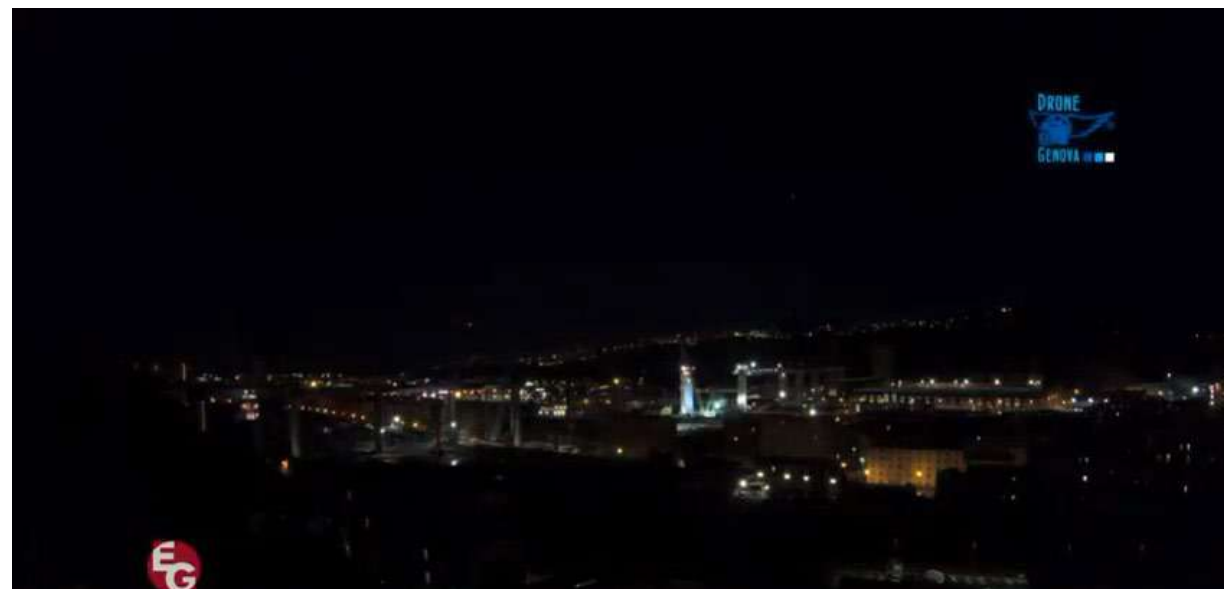
High Tech Structure: >240 sensors!!!

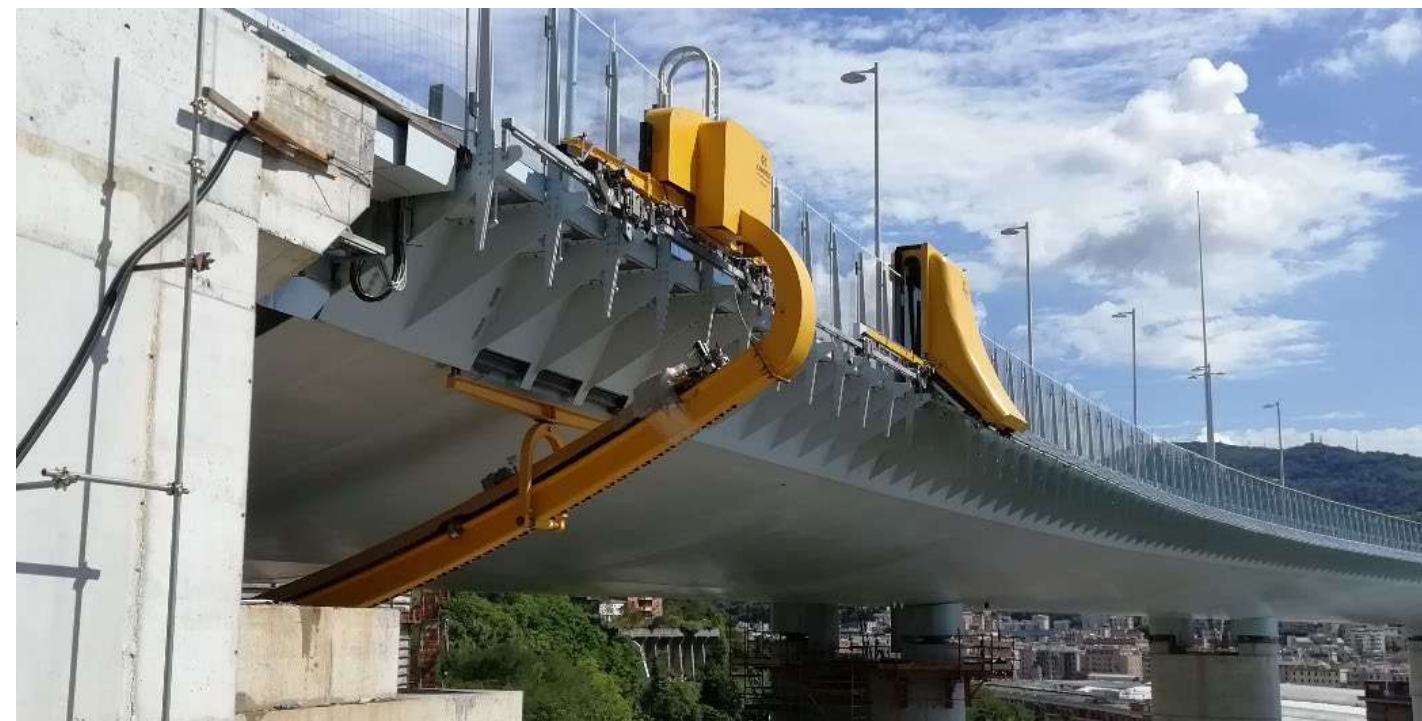
MECHATRONICS

Monitoring:

- Underside of the deck
- Head of piers

Maintenance:

- Sound barriers
- Solar panels

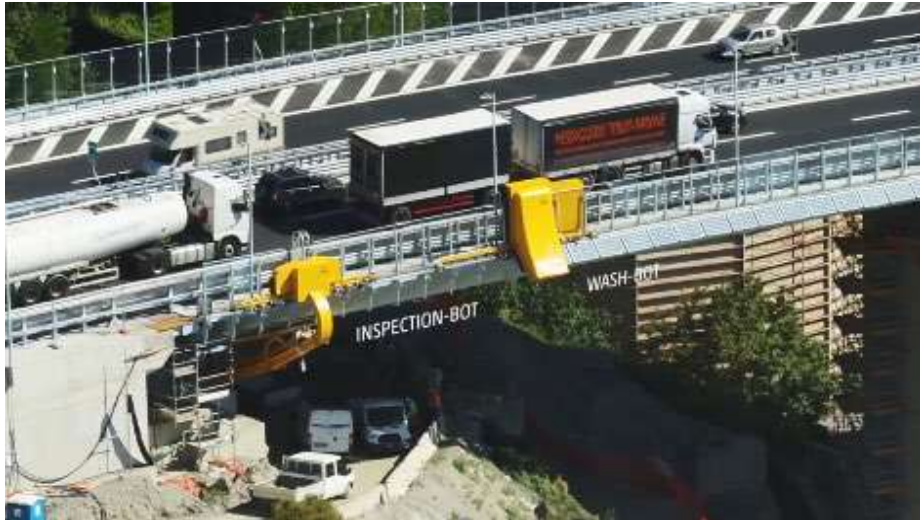
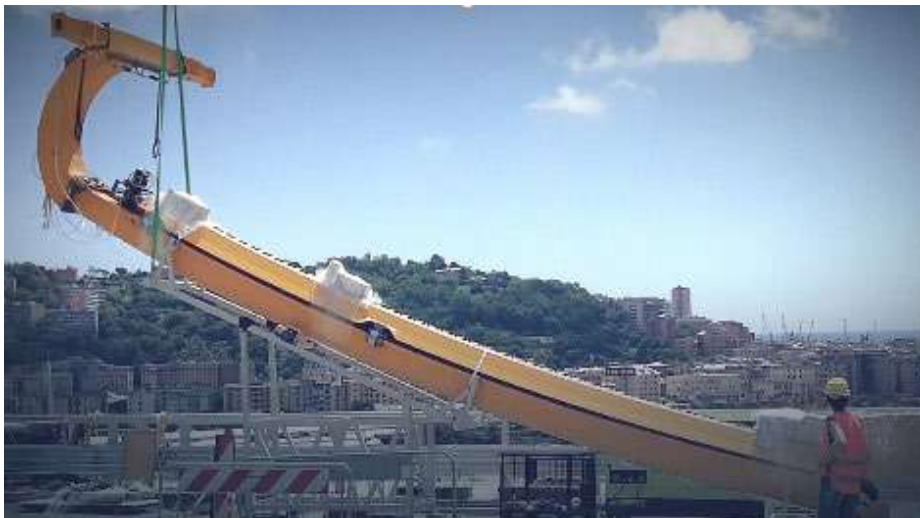
Weight: **2400 kg**
(arm: 300kg of carbon fiber structure)

Payload of the arm:
On the tip: **80 kg**
Distributed: **250 kg**

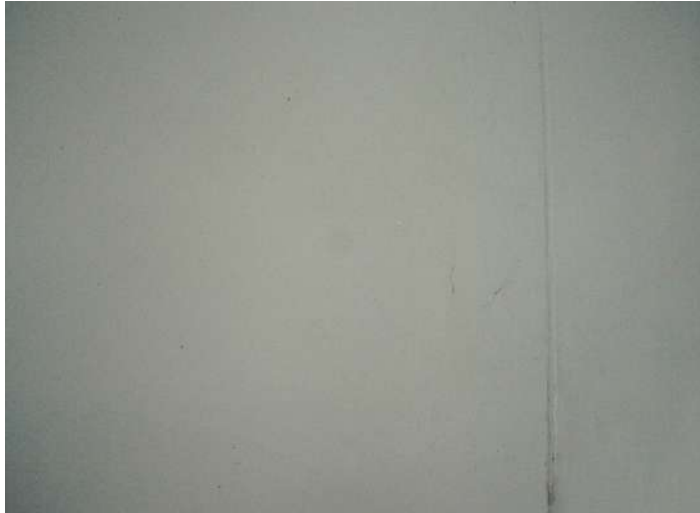
FIRST DEFECT DETECTION (2021, February)

The first scanning the whole bridge was covered and more than 30000 pictures were taken. A couple of them are shown in the following. **THIS IS THE BRIDGE PATTERN «REFERENCE»**

Not defects DETECTED by the algorithm, because the bridge was new!

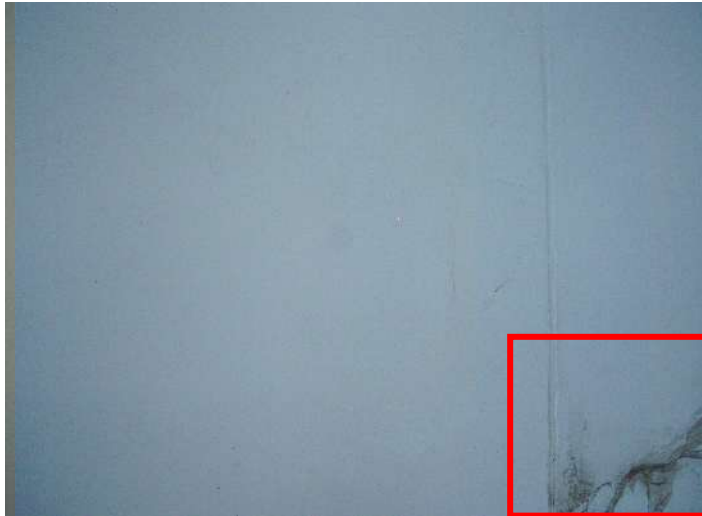
THIRD DEFECT DETECTION (2023, December)

The third inspection involved almost half bridge with around 1000 pictures (statistically determined) to assess where some defects were coming out: considering that only some dirty areas were found, the captured pictures were drastically reduced compared to 30000 for scanning the whole bridge.

Evident dirt zone EASILY DETECTED by the algorithm

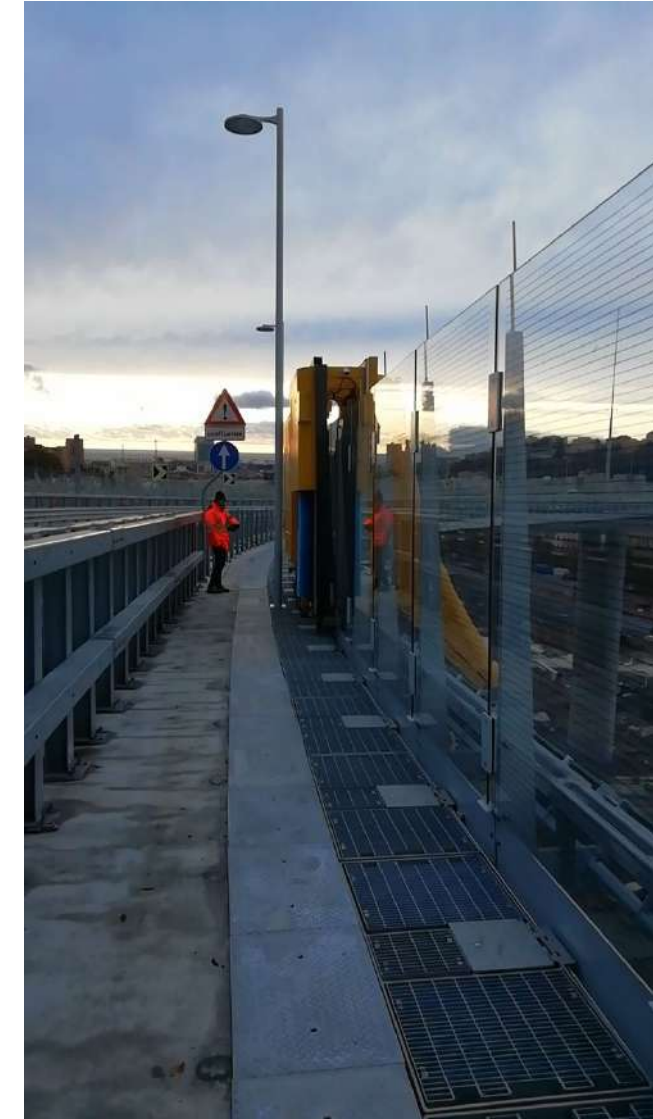
Wash

The transversal movement compensates the structure misalignments (rails, glasses, floor, etc.)
